Tool wear by dissolution during machining of alloy 718 and Waspaloy: a comparative study using diffusion couples

Hoier, P., Surreddi, K., Klement, U. (2020). Tool wear by dissolution during machining of alloy 718 and Waspaloy: a comparative study using diffusion couples. *International Journal of Advanced Manufacturing Technology*, 106(3-4): 1431-1440. <http://dx.doi.org/10.1007/s00170-019-04805-9>

Philipp Hoier¹ · Kumar Babu Surreddi^{2,3} · Uta Klement¹

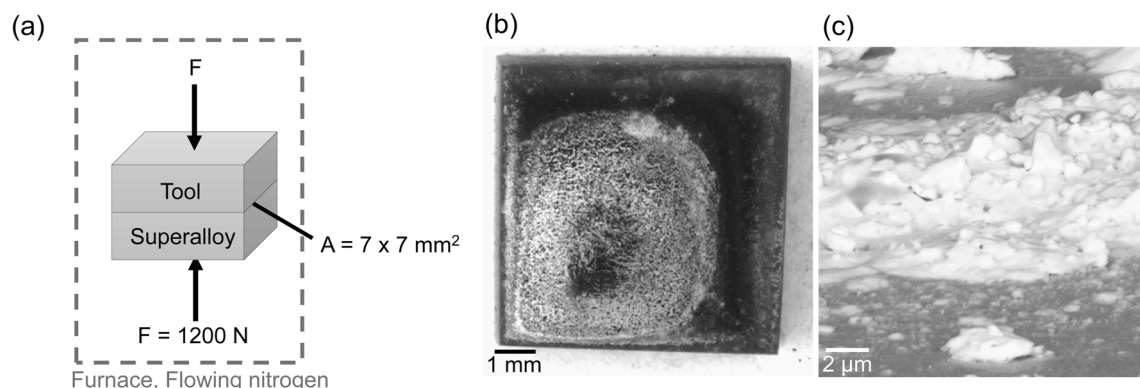
Fig. 1 Schematic setup of the diffusion couple tests with contact surface (“A”) and applied force (“F”) indicated (a); separated diffusion couple of Waspaloy after testing at 1000 °C shown in top-view (b), and tilted view

using SEM (c). Locally, several micrometer thick layers of tool material (bright particles are WC) are bonded to the Waspaloy sample

For each experiment, one diffusion couple comprising one of the two superalloys and a sample of the tool material was tested under controlled conditions. Tool and superalloy were brought in contact so that the mating surfaces were square-shaped with 7 mm side length. Furthermore, to achieve good contact during the tests, the contact surfaces were ground and polished with 1 μm diamond suspension as the final step. In that way, a total of four samples were prepared (two for each superalloy) and tested in accordance with Table 2. For each test, the sample was held together by applying a force of 1200 N corresponding to a pressure of ~ 24.5 MPa in compression for 90 min at two test temperatures. Flowing nitrogen was used as protective gas to prevent oxidation of the samples during the tests. A schematic of the experimental setup can be seen in Fig. 1a.

After testing for the set time and subsequent cooling to room temperature, the contact pressure was released from the samples. It was found that firm bonding between the tool material and the corresponding superalloy samples had occurred in all cases except for Waspaloy tested at 1000 °C. Here the vast majority of the tool material had broken off. It is believed that during cooling down, differences between the thermal expansion coefficients of the tool material and the respective superalloys lead to build-up of stresses which resulted in the debonding. However, closer examination by optical microscopy and SEM revealed that pieces of tool material were left adherent to the Waspaloy surface in contact with the tool during the test (Fig. 1b and c). Therefore, bonding had occurred during the test.

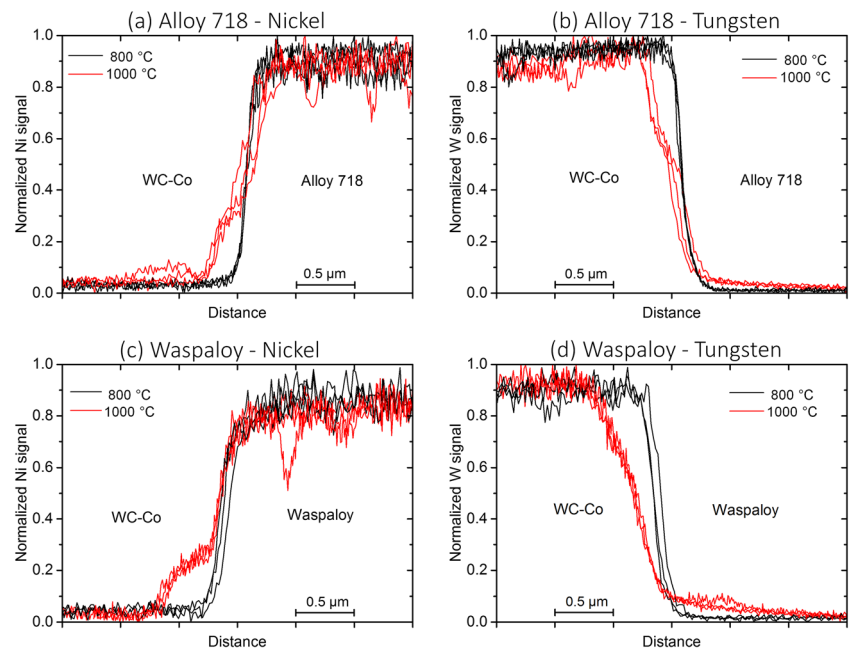
Fig. 3 Qualitative comparison of EDS line scans across the workpiece–tool interfaces after the four tests. Shown are normalized signals of Ni (**a, c**) and W (**b, d**)

For qualitative comparison of interdiffusion between the materials, at least five EDS line scans were taken across each tool–workpiece interface. Three of these line scans from each sample are presented in Fig. 3. Shown are the normalized

signal intensities of nickel and tungsten across the diffusion couple interfaces after the tests. In all graphs, a steep decrease or increase of X-rays originating from tungsten and nickel, respectively, can be seen in close vicinity of the tool–superalloy interface (the interface is approximately at the center of the x -axis). When comparing the line scans corresponding to the tests at 800 °C with the ones obtained after 1000 °C, a clear difference can be observed. The higher test temperature yielded in a more shallow increase and decay of tungsten and nickel, respectively. This can be connected to increased inter-diffusion between the tool and superalloys which increased the respective element's X-ray signals within about 0.5 μm distance from the interface. This is the case for both the alloy 718 and the Waspaloy containing sample and no significant differences can be observed between the two alloys. Furthermore and as can be seen in Fig. 3a and b, it should be noted that the EDS line scans of the alloy 718 diffusion couple tested at 1000 °C show no significant change in the X-ray intensities at the location of the bright phase.

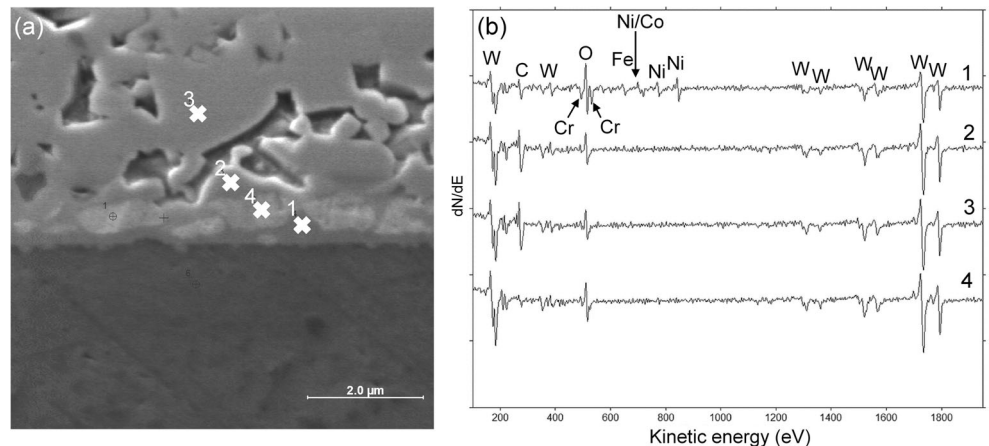
Fig. 4 AES survey scans taken in close vicinity of the interface of the alloy 718 diffusion couple tested at 1000 °C. **a** SEM image with points of analysis. **b** Differentiated AES spectra with peak designations

Complementary to EDS, additional analysis by means of AES was carried out for the samples tested at 1000 °C. As compared with EDS, AES offers higher spatial resolution and higher sensitivity on the orders of 10 nm and 0.1 at.%, respectively [31]. Figure 4 shows derivatives of AES survey spectra obtained for the diffusion couple which contains alloy 718. Characteristic Auger peaks are marked with the corresponding elements. Spectrum 1 shows presence of nickel, iron, and chromium in the tool, confirming diffusion of elements from the superalloy into the tool. At further distance from the

interface (spectra 2 and 3), no elements from the superalloy were detected, which can be seen by the absence of the corresponding peaks in the AES spectra. Spectrum 4 was obtained on the bright phase formed in close vicinity to the diffusion interface (see also Fig. 2b). As can be seen, solely tungsten, carbon, and oxygen are present in the spectrum. The presence of oxygen in all spectra is likely to be the result of air which was entrapped between the mating sample surfaces. Even though these surfaces were polished for improved contact during the tests, remaining small-scale surface roughness can lead to small gaps between the mating surfaces. The entrapped air then caused diffusion of oxygen into the diffusion couples and can explain the oxygen peaks in the shown spectra. Similar to the alloy 718 sample tested at 1000 °C, diffusion of elements of the superalloy into a narrow region of the tool adjacent to the diffusion interface was also confirmed for the corresponding Waspaloy sample.

Concerning the diffusion of workpiece atoms into the tool, it was observed that superalloy elements are present in a narrow region of the tool after the diffusion couple tests conducted at 1000 °C (see Figs. 3 and 4). Additionally, significant carbon depletion and formation of tungsten within the tool material were observed in the diffusion couple containing alloy 718 (see Figs. 2 and 5). In the corresponding Waspaloy containing diffusion couple, these phenomena were less pronounced and no significant carbon depletion and formation of tungsten were observable using the employed characterization techniques. A possible explanation for the different responses of the tool material during the diffusion couple tests is that the two superalloys contain different types and quantities of carbide forming elements. Of the present alloying elements, niobium has the strongest tendency to form carbides, followed by titanium [34]. Alloy 718 contains about 5.5 wt% niobium and about 0.9 wt% titanium, whereas Waspaloy contains no niobium and about 3.1 wt% titanium (see Table 1). Due to its chemical composition, alloy 718 should therefore have higher affinity to carbon which could explain the observed carbon depletion of the tool material in close vicinity to the diffusion interface.

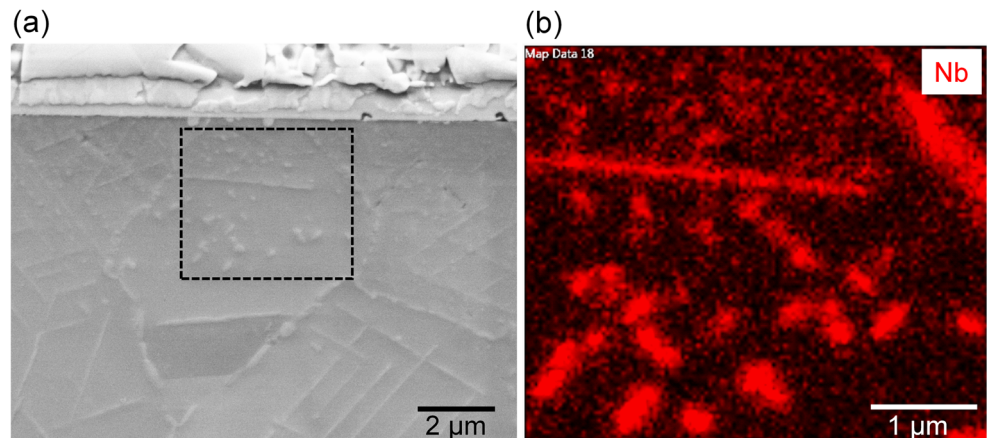
Fig. 6 Niobium-rich precipitates in alloy 718 in close vicinity to the diffusion interface after testing at 1000 °C. **a** SEM micrograph. **b** EDS map showing the distribution of niobium

Furthermore, niobium-rich phases were found to form in alloy 718 in close proximity to the diffusion interface (see Fig. 6). The shown appearance is characteristic for the entire length of the diffusion interface for the alloy 718 diffusion couple tested at 1000 °C.
